# Seeps and Springs Report for the Kings Mountain Lithium Mine, Cleveland County, North Carolina

NOVEMBER 2022

PREPARED FOR  
**Albemarle U.S., Inc.**

PREPARED BY  
**SWCA Environmental Consultants**

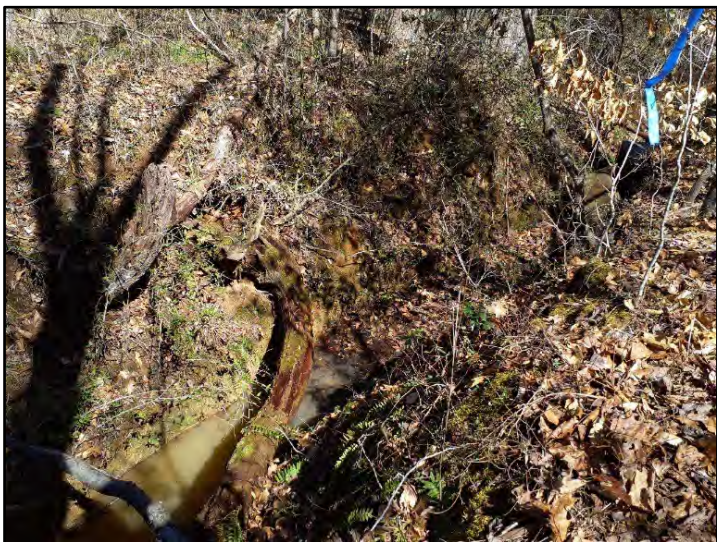
Resource Name	Classification	Flow	Resource Location	Observations	Photo #
S-A02	Spring - Intermittent stream	Weak	35.207162, -81.363059 Main Site – North of I-85	Stream is depicted as an intermittent National Hydrography Dataset flowline stream. However, during the delineation, most of it was an ephemeral stream. The coordinates represent the transition zone from ephemeral to intermittent where groundwater emerges.	1
S-A04	Spring - Intermittent stream	Moderate	35.209266, -81.366336 Main Site – North of I-85	Has an ephemeral portion upstream of intermittent portion. There appears to be a small historic stone spring house adjacent to the area where groundwater emerges.	2; 39
S-A06	Spring - Intermittent stream	Moderate	35.212176, -81.368552 Main Site – North of I-85	Groundwater-fed stream with additional contribution from surrounding seepage wetland W-A03. Originates within wetland and forms into a perennial stream.	3

**Photo 1. Intermittent stream spring S-A02.**

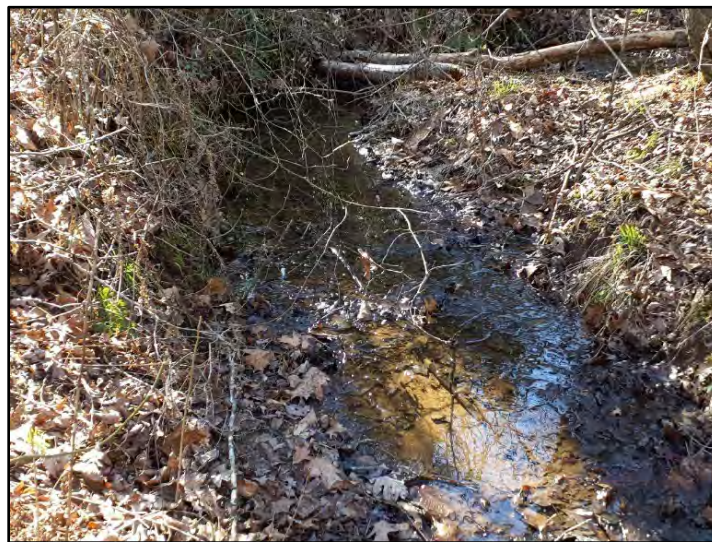
**Photo 2. Intermittent stream spring S-A04.**

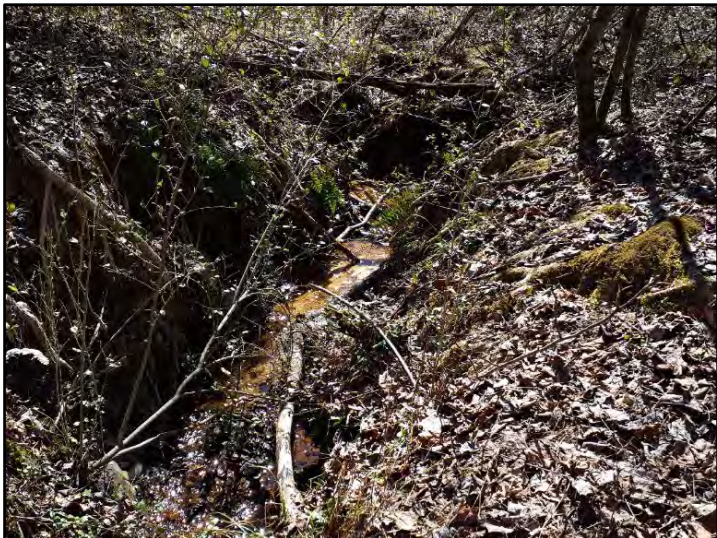
**Photo 3. Intermittent stream spring S-A06.**

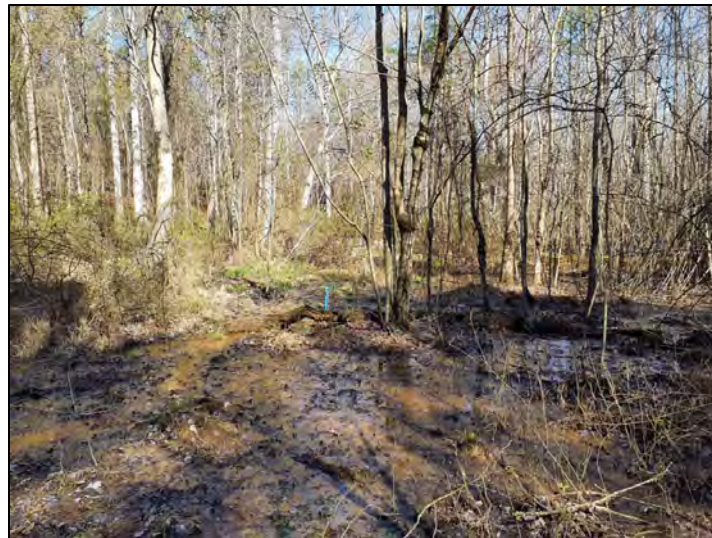
W-A03	Seepage wetland	N/A	35.212005, -81.368541 Main Site – North of I-85	Large seepage wetland at the toe slope of a hillside. Contributes to stream S-A06.	4
S-A09	Spring - Intermittent stream	Moderate	35.213468, -81.367636 Main Site – North of I-85	Groundwater-fed stream that connects into perennial S-A07. Small spring.	5
S-A13	Spring - Intermittent stream	Moderate	35.218202, -81.358818 Main Site – North of I-85	Receives flow from upstream wetland as well as groundwater. Originates as spring from bank.	6
S-B05	Spring - Intermittent stream	Moderate	35.212957, -81.364604 Main Site – North of I-85	Groundwater-fed stream in the floodplain portion of South Creek (S-A05).	7
GW-B02-SPRING	Spring	Weak	35.212645, -81.36441 Main Site – North of I-85	Small hillside spring with no channelization. Contributes to wetland W-B02.	8
W-A17	Potential seepage wetland	N/A	35.220078, -81.358215 Main Site – North of I-85	Ponded area on margin of mine pit shelf. Potentially just accumulated rainwater on rock but was identified as potential spring/seep by other on-site scientists. Could not confirm a water source at time of visit.	9

**Photo 4. Seepage wetland W-A03.**

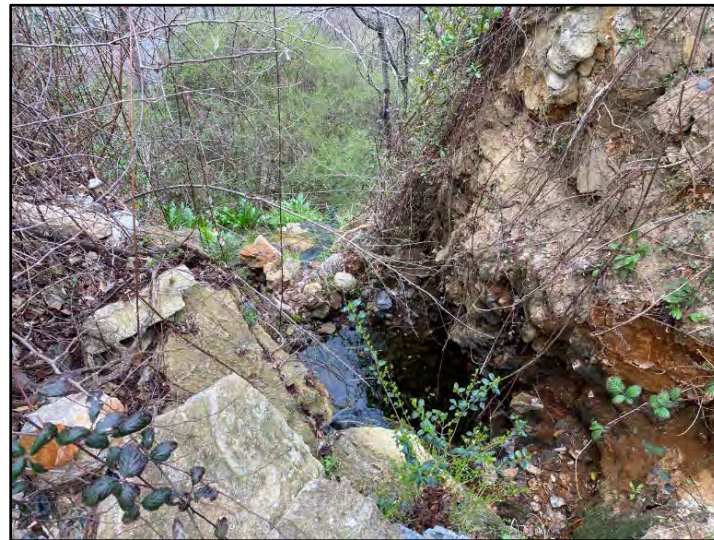
S-A43	Spring - Intermittent stream	Moderate	35.221428, -81.357748 Main Site – North of I-85	Previously identified spring coming out of mining pit hillside.	10
S-A14	Spring - Intermittent stream	Weak	35.229068, -81.347242 Main Site – North of I-85	Stream originating from groundwater within the Project area. Resource appeared to potentially originate from a stormwater structure just outside of the Project area.	11
S-B13	Spring - Intermittent stream	Weak	35.218825, -81.350866 Main Site – North of I-85	Originates from groundwater and wetland W-B12.	12
GW-B01	Spring	Weak	35.219026, -81.350696 Main Site – North of I-85	Spring lacking channelization originating within Albemarle and Martin Marietta boundary.	13

**Photo 10. Hillside spring S-A43.**

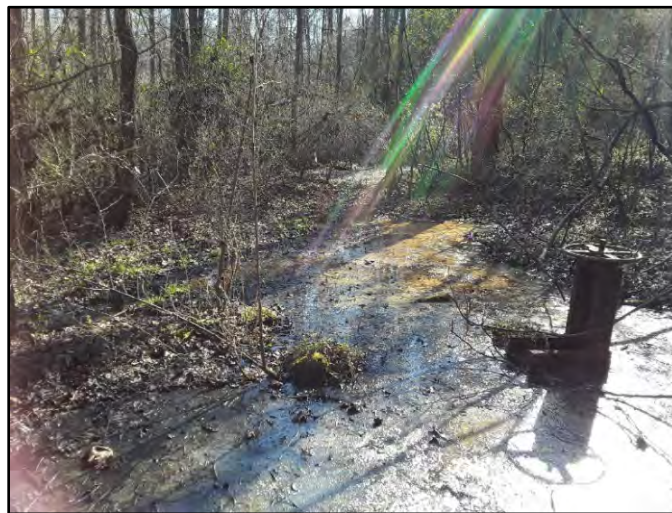
Resource Name	Classification	Flow	Resource Location	Observations	Photo #
W-B08-PFO	Seepage wetland	N/A	35.213617, -81.354167 Main Site – North of I-85	Seepage wetland located along Kings Creek (S-B08). Old piping and turn valve are located within wetland.	14
GW-B04-SEEP	Seep	Moderate	35.21336, -81.354173 Main Site – North of I-85	Located along Kings Creek (S-B08). Seep 6 feet wide coming out of marshy hillside and rock.	15
GW-B03-SEEP	Seep	Moderate	35.213247, -81.354218 Main Site – North of I-85	Seep coming out of rock on hillside adjacent to Kings Creek (S-B08).	16
GW-B05-SPRING	Spring	Weak	35.215413, -81.352328 Main Site – North of I-85	Feeds into stream S-B10, which is a short tributary to Kings Creek.	17
S-A17	Spring - Intermittent stream	Moderate	35.207493, -81.348682 Main Site – South of I-85	Has an ephemeral portion upstream of groundwater origination. Eventually connects into large wetland associated with Kings Creek. Intermittent portion originates as groundwater discharge.	18

**Photo 14. Seepage wetland W-B08-PFO. Water color is a result of naturally occurring iron-oxidizing bacteria.**

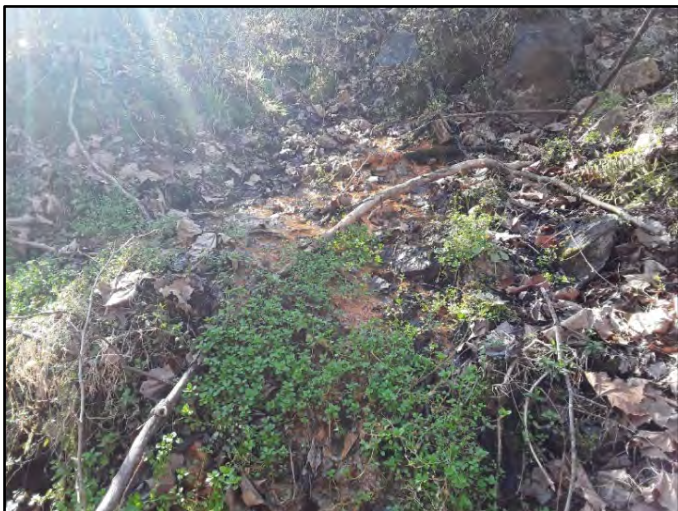
**Photo 15. Groundwater seep GW-B04-SEEP. Water color is a result of naturally occurring iron-oxidizing bacteria.**

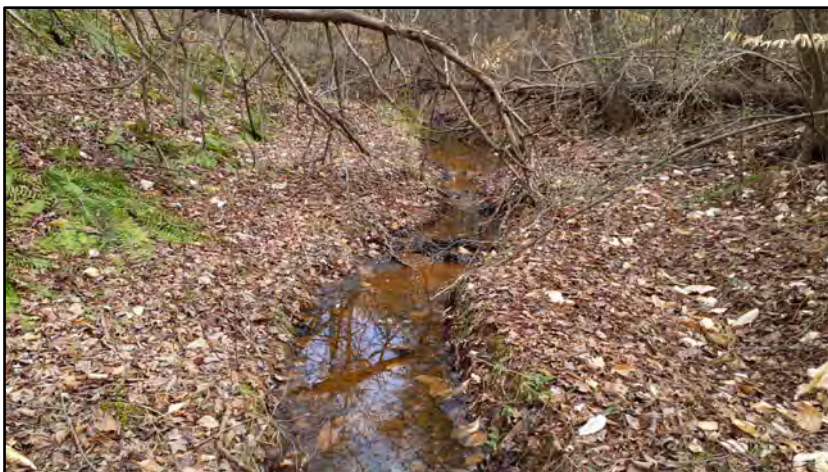
**Photo 19. Intermittent stream spring S-A25. Water color is a result of naturally occurring iron-oxidizing bacteria.**

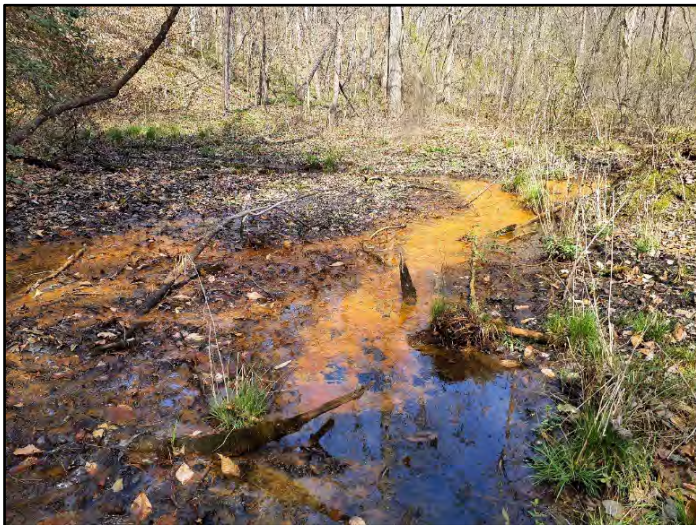
**Photo 21. Seepage wetland W-A30. Water color is a result of naturally occurring iron-oxidizing bacteria.**

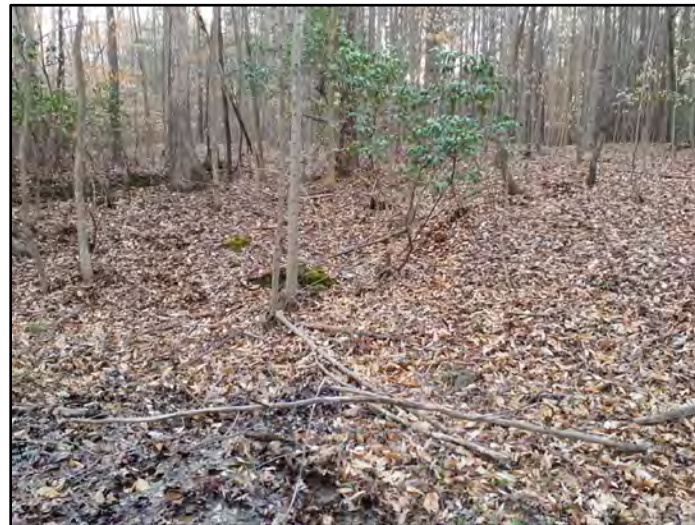
W-A31	Seepage wetland	N/A	35.211152, -81.334734 Albemarle East Property	Small seepage wetland that connects into perennial S-B29	22
W-A32	Seepage wetland	N/A	35.21015, -81.330551 Albemarle East Property	Seepage wetlands that connect into perennial S-B31. Other portions of this wetland are related to the stream floodplain but are all hydrologically connected.	23
S-A41	Spring - Intermittent stream	Moderate	35.210772, -81.327383 Albemarle East Property	Spring/groundwater fed stream found within W-A33.	24
W-A24	Seepage wetland	N/A	35.204011, -81.325536 Albemarle East Property	Seepage wetland originating at bottom of hillside and associated with S-A36.	25

**Photo 22. Hillside seepage wetland W-A31.**

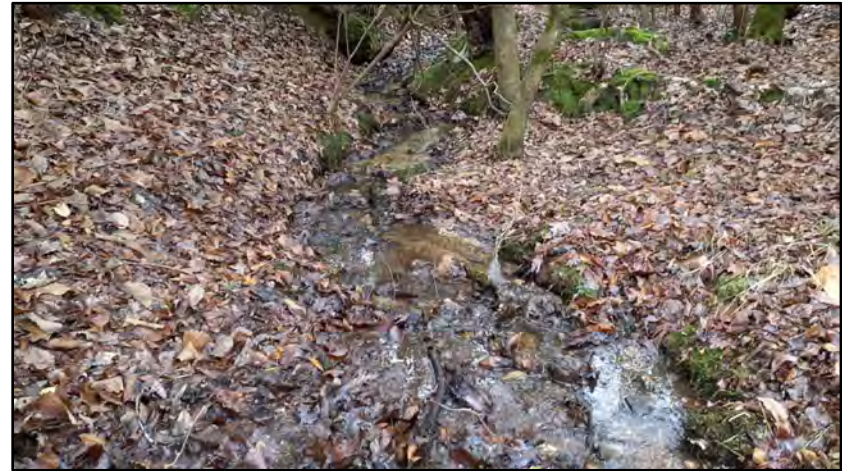
<b>Resource Name</b>	<b>Classification</b>	<b>Flow</b>	<b>Resource Location</b>	<b>Observations</b>	<b>Photo #</b>
S-A36	Spring - Perennial stream	Strong	35.2041493, -81.3254499 Albemarle East Property	Spring-fed stream surrounded by wetland W-A24, which is also groundwater-fed.	26
S-A34	Spring - Intermittent stream	Moderate	35.20409, -81.32746 Albemarle East Property	Stream originates from groundwater seepage. An ephemeral portion of the stream is located upstream.	27
W-A22	Seepage wetland	N/A	35.201692, -81.334994 Albemarle East Property	Hillside seepage wetland that becomes channelized into S-A31.	28
S-A31	Spring - Intermittent stream	Moderate	35.201543, -81.334935 Albemarle East Property	Originates from channelization of seepage wetland W-A22.	29
S-A30	Spring - Intermittent stream	Moderate	35.20066, -81.335996 Albemarle East Property	Short groundwater-fed stream. Observed after a heavy rainfall.	30

**Photo 26. Groundwater-fed perennial stream spring S-A36.**

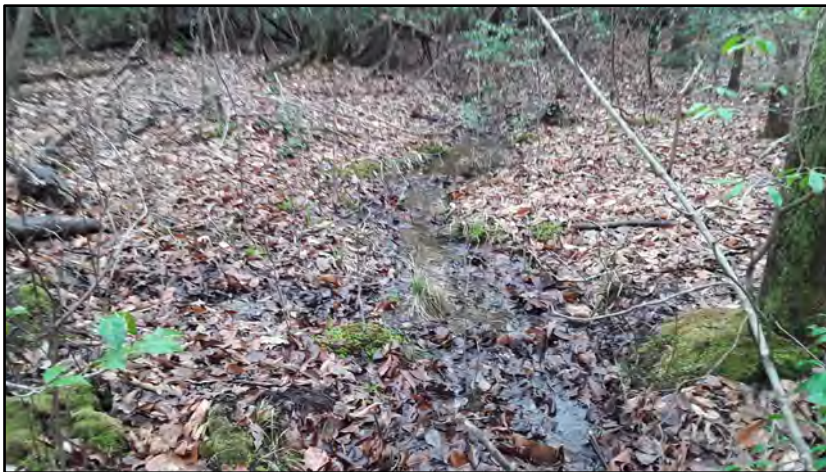
S-B18	Spring - Intermittent stream	Moderate	35.20177, -81.334349 Albemarle East Property	Groundwater-fed stream. Originates within wetland W-A21.	31
W-B17	Seepage wetland	N/A	35.199879, -81.340088 Albemarle East Property	Seepage wetland on hillside that connects into perennial S-B16.	32
S-A28	Spring - Intermittent stream	Moderate	35.202061, -81.336957 Albemarle East Property	Groundwater-fed stream that connects into S-B16.	33
S-A29	Spring - Intermittent stream	Moderate	35.202642, -81.339072 Albemarle East Property	Groundwater-fed stream that connects into S-B16. Fed by seepage wetland W-A19 upstream of it.	34
W-A19	Seepage wetland	N/A	35.202711, -81.339068; 35.202238, -81.339486 Albemarle East Property	Seepage wetland that becomes channelized into S-A29.	35
W-A26	Seepage wetland	N/A	35.207473, -81.334643 Albemarle East Property	Seepage wetland that connects into perennial S-B22.	36
W-A35	Seepage wetland	N/A	35.204483, -81.335837 Albemarle East Property	Seepage wetland that becomes channelized into S-A42.	37

**Photo 31. Groundwater-fed intermittent stream spring S-B18.**

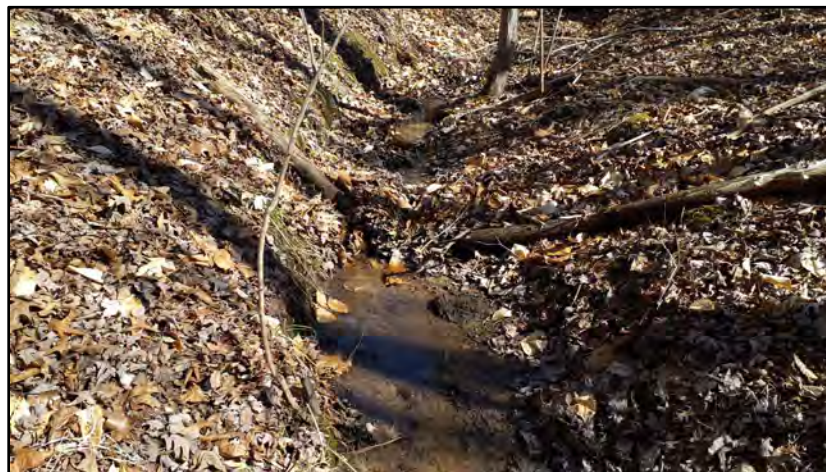
S-A42	Spring - Intermittent stream	Weak	35.2045106, -81.3358268 Albemarle East Property	Groundwater-fed stream. Associated with seepage stream W-A35.	38

**Photo 38. Groundwater-fed intermittent stream spring S-A42.**

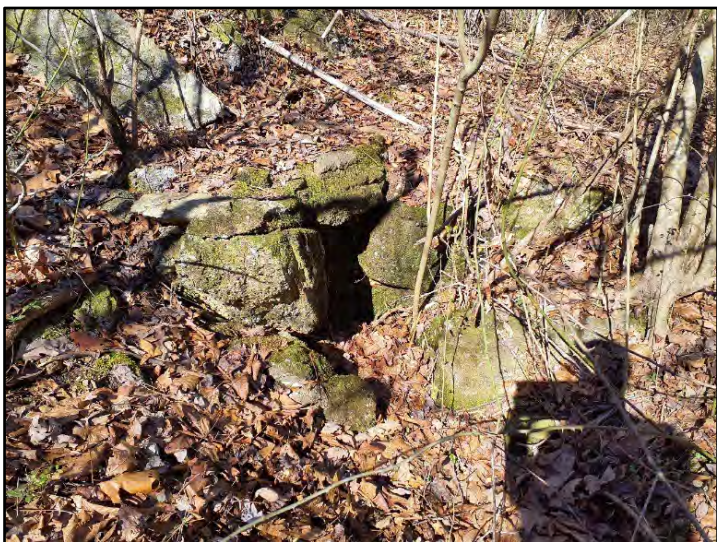
**Photo 39. Small stone spring house by S-A04 (shown in Photo 2).**
